Talavera Floodplain Delineation Study Technical Review

Noah's Ark Group Study
Las Cruces, New Mexico
September 17, 2008

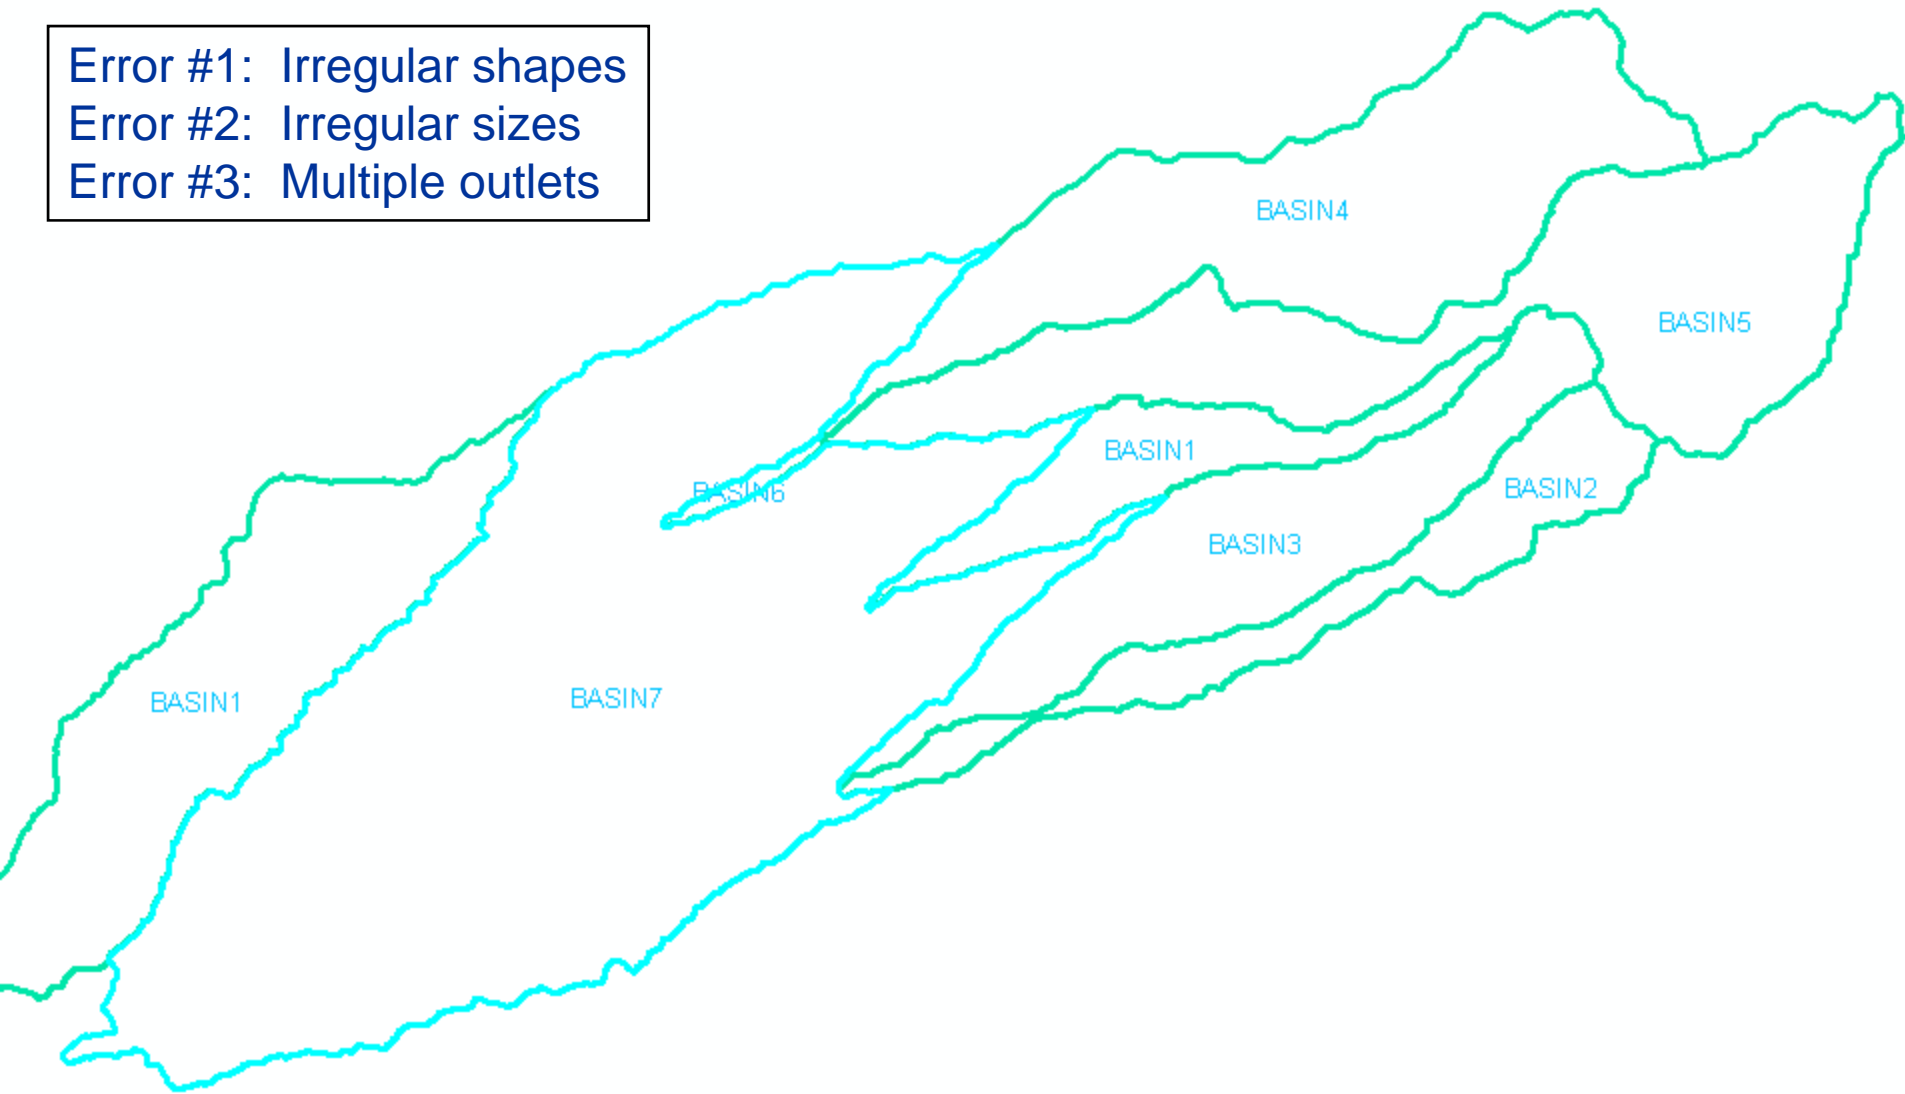
Hydrology: Subbasin Delineation

Error #1: Irregular shapes
Error #2: Irregular sizes
Error #3: Multiple outlets

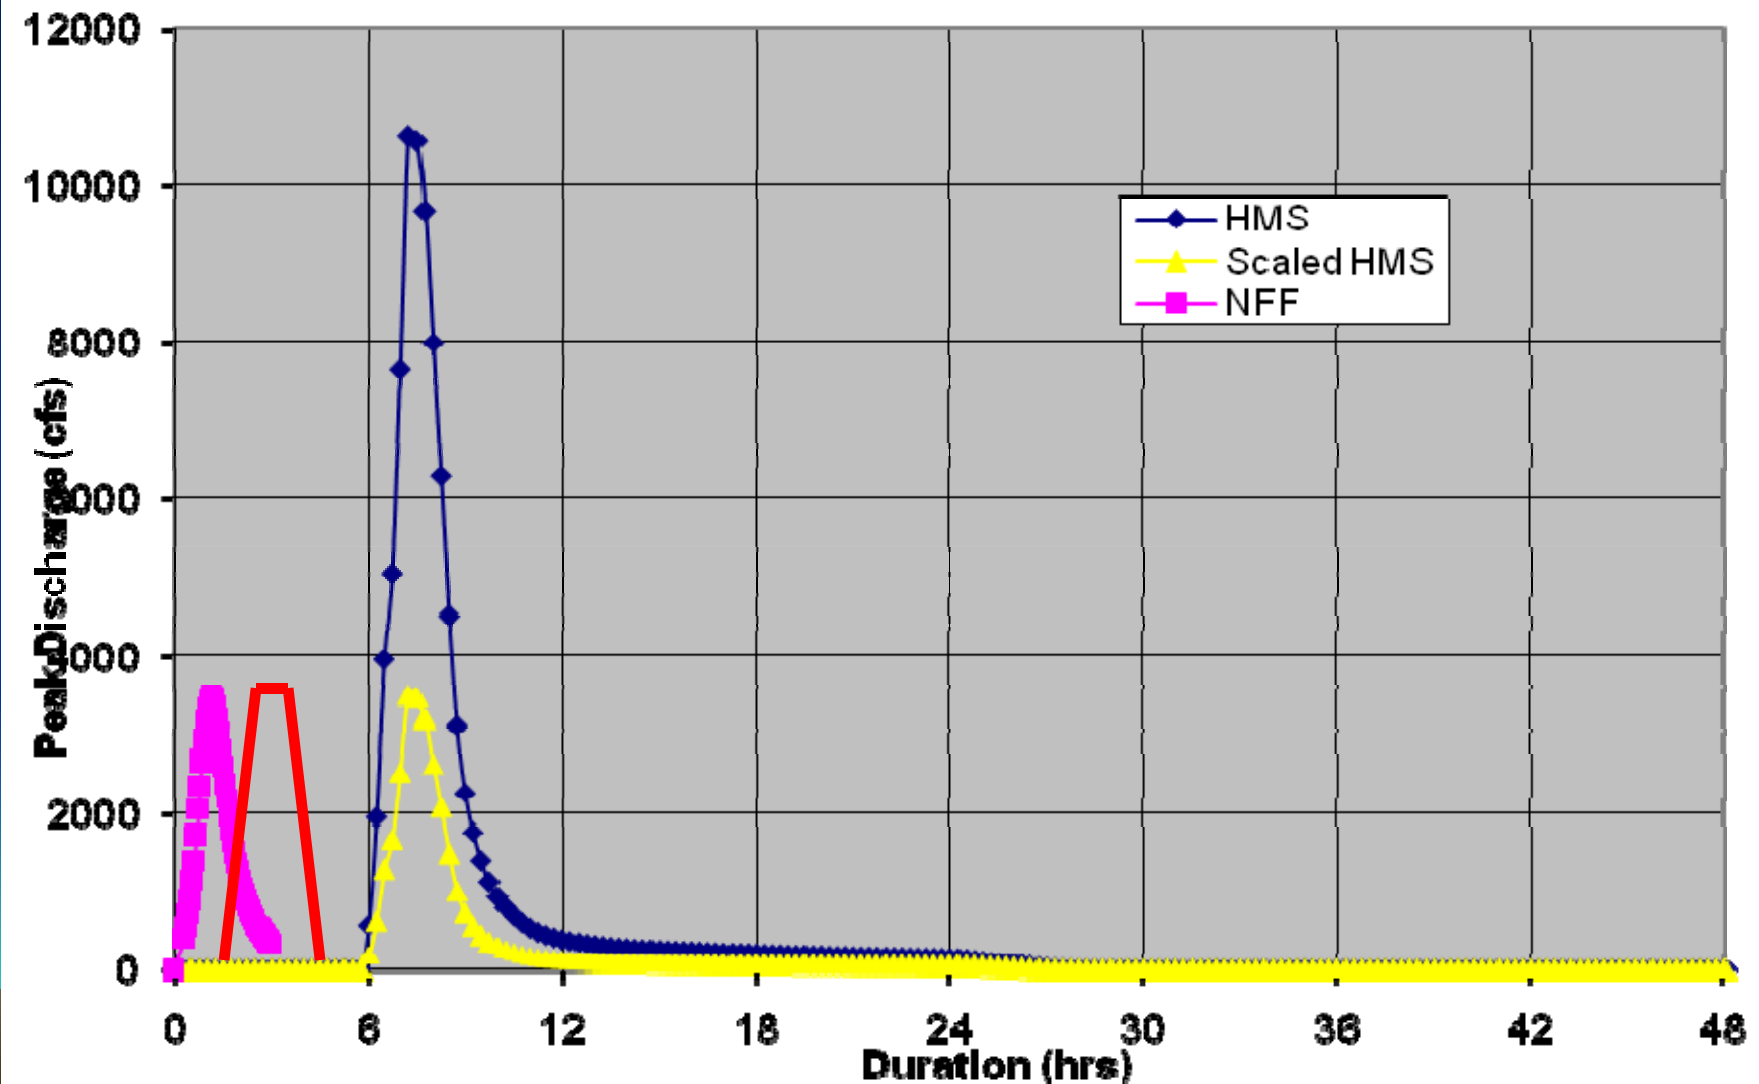
Hydrology: Hydrograph Shape

Watershed Hydrograph Comparison for Fillmore Arroyo

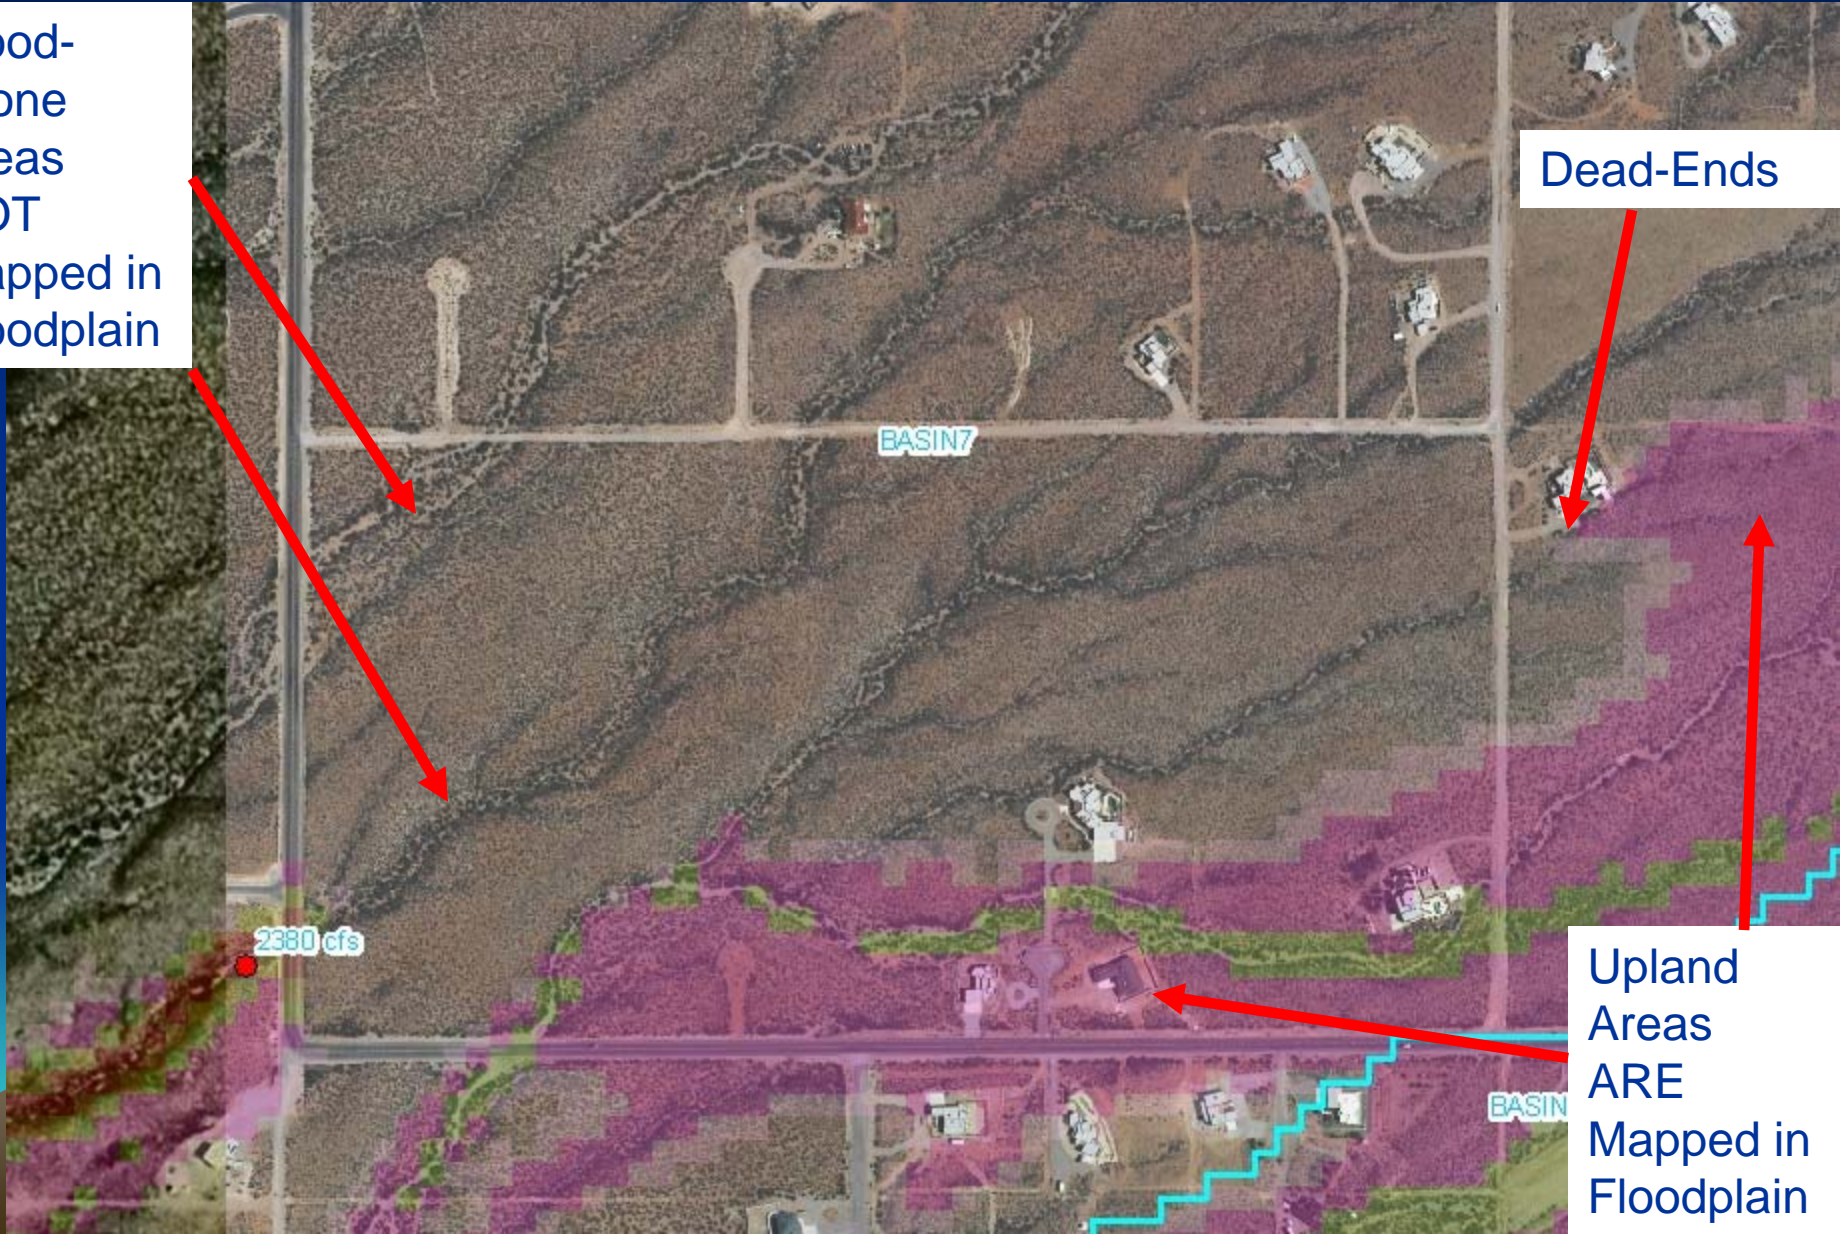
Technical Flaws: Map Results

Flood-Prone Areas NOT Mapped in Floodplain

Dead-Ends

BASIN7

2380 cfs

Upland Areas ARE Mapped in Floodplain

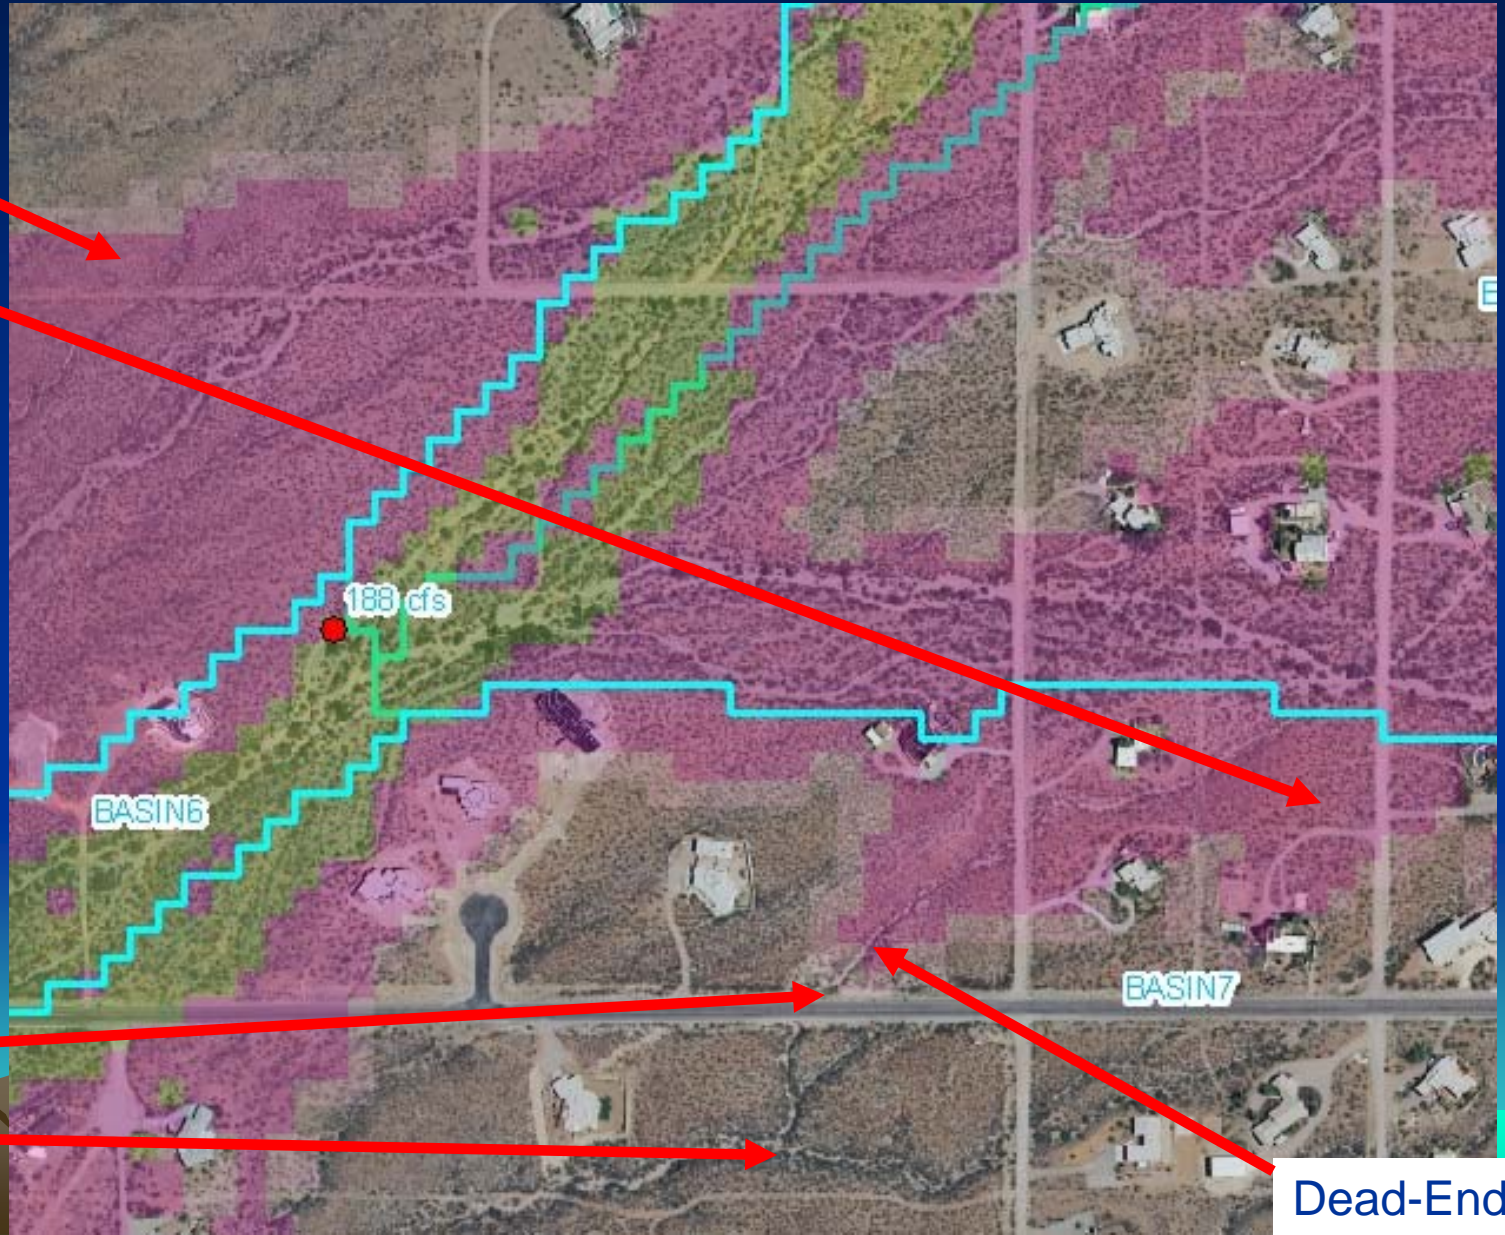
Technical Flaws: Map Results

Upland
Areas
ARE
Mapped in
Floodplain

Flood-
Prone
Areas
NOT
Mapped in
Floodplain

Dead-Ends
